REPORT

April 30, 2021

Re: Building at 2605 Condit St. - Structural Inspection

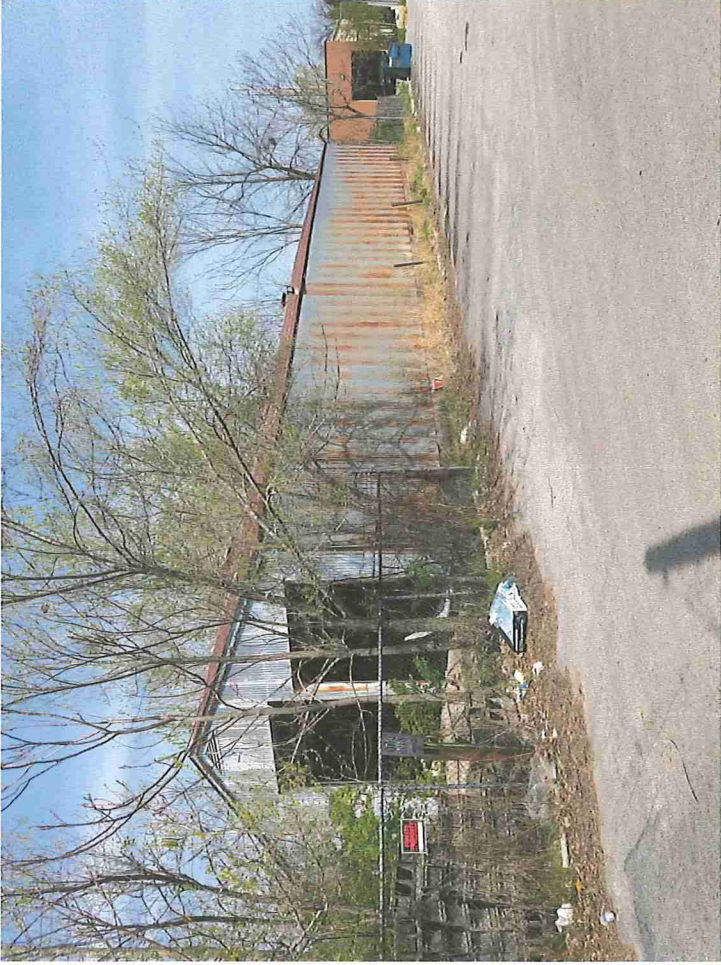
Fig. 1 - Exterior South & East Walls

Pictures of the exterior roofing and siding along the south, east and north walls. Dense foliage along the west wall prevented clear picture of that side. Both the corrugated metal roof decking and siding show signs of weathering/corrosion. Panels appeared to be intact with no visible holes. No gutters on either the east or west wall. Visible areas of the roofing and siding on the inside looked to be in good condition, free from rust. However, there may be areas of the roof that do leak during rain events especially around the skylights. Figure 2 indicates location where I noticed animal burrow hole under concrete floor. Refer to Fig. 8.

- c. Concrete Slab-on-Grade - Building's concrete floor slab appears in good condition,**
- d. Roofing & Siding – Surface rust visible on the exterior sides of both roofing and siding. No corrosion visible on the interior sides indicating there is no “rust through”. There may be some areas of the roof that leak during rain events. In-kind replacement of roofing and siding may be required,**

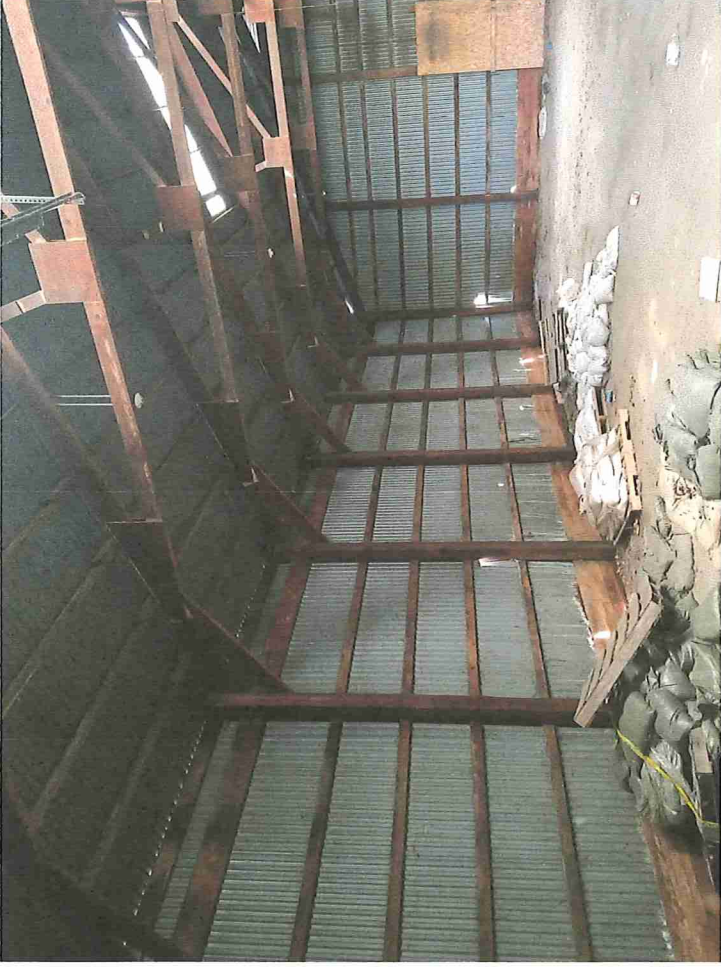
Fig. 3 - Interior Frame NW Corner

Pictures taken in the north room area. The existing wood roof trusses, heavy timber columns and roof/wall support beams are illustrated in the photos. Structure framing appeared in good condition, with no obvious visual damage or deterioration. Wood members supporting the roof decking and wall siding also appeared in good condition. There were no visible signs of water damage to any of the structural members however, roof may have leaks. Concrete floor appears to be in good condition also. In Fig.4 light can be seen along eave joint which indicates weather flashing between the roof & wall panels is missing.

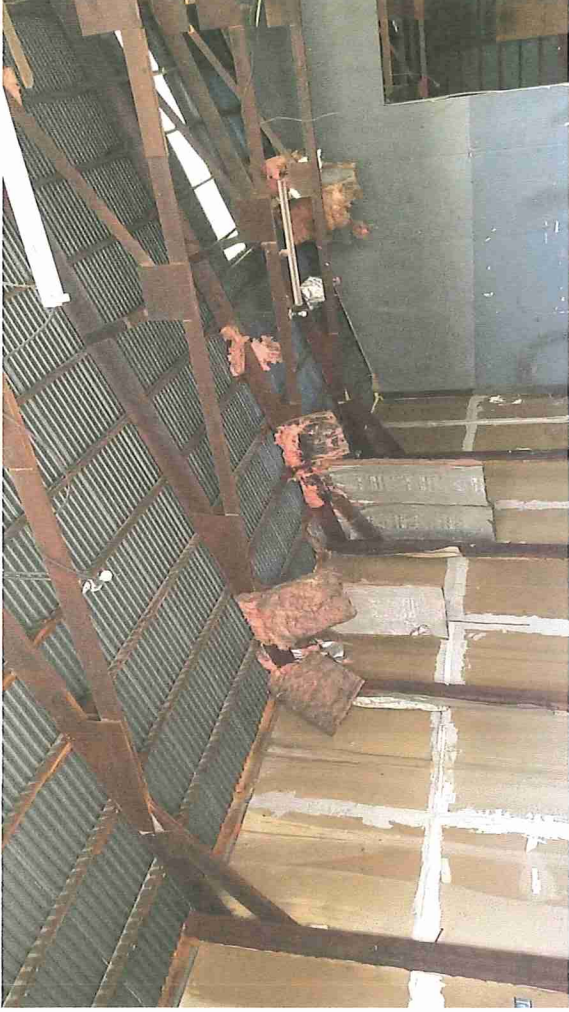
Fig. 5 - Interior Frame West Side of South End Room

Pictures taken in the south room area. Views of the wood roof trusses show them to be in good condition with pieces of fallen ceiling insulation hanging from them. There was no obvious visual damage or deterioration on the roof trusses with the exception of possible deterioration at the bottom member of one of the roof trusses (refer to Fig. 7). Wood beam/purlins appear in good condition. Complete evaluation of the heavy timber columns and the wall beam/girts was not possible since they were covered by drywall. There were no visible signs of water damage to any of the structural members however, the roof may have leaks. The concrete floor in this room also appeared to be in good condition (not seen in photos).

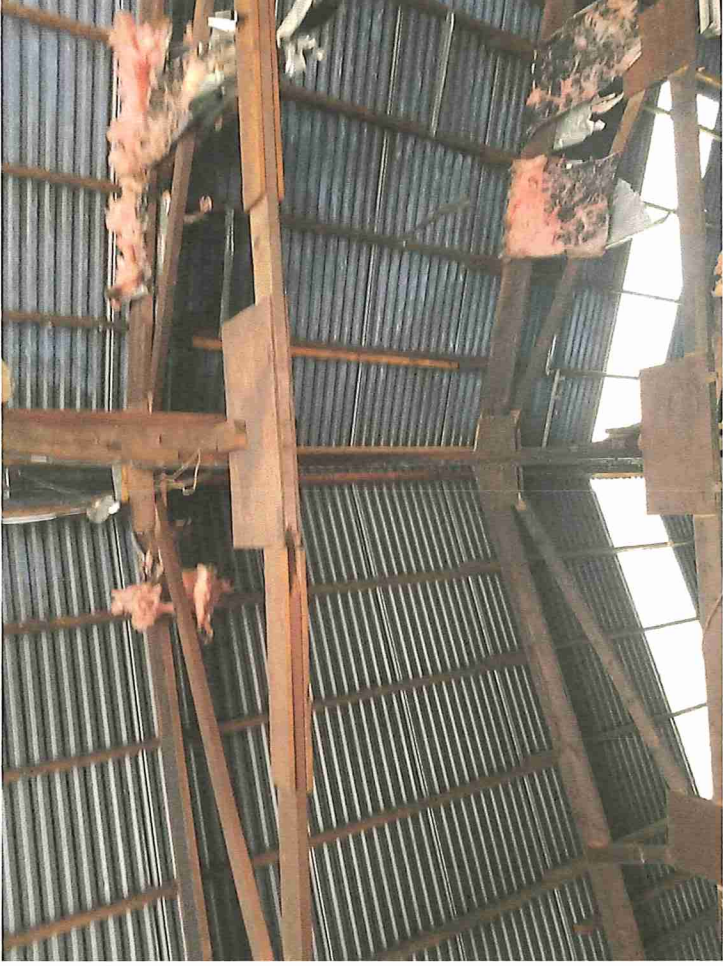
Fig. 7 - View of Wood Truss in South End Room

Photo illustrates a potential problem in an area along the bottom member of one of the roof trusses, located in the south room. Was hard to determine the extent of the wood damage from grade level and partial obstruction from pieces of plywood that had been added on each side of the truss member. A more detailed inspection of this area would require a lift or ladder,

- a. Building Main Structural Frame – The existing structural roof and wall framing for the building appears to be in good condition with no obvious/visible structural damage or deterioration other than the area noted in Fig. 7 mentioned above. Assuming the building was originally designed in accordance with the applicable area code at that time, the framing should be able to continue functioning as originally designed. However, a more detailed structural evaluation is required for the truss highlighted in Fig. 7 and possible repairs may be needed to make the roof safe for occupancy,**

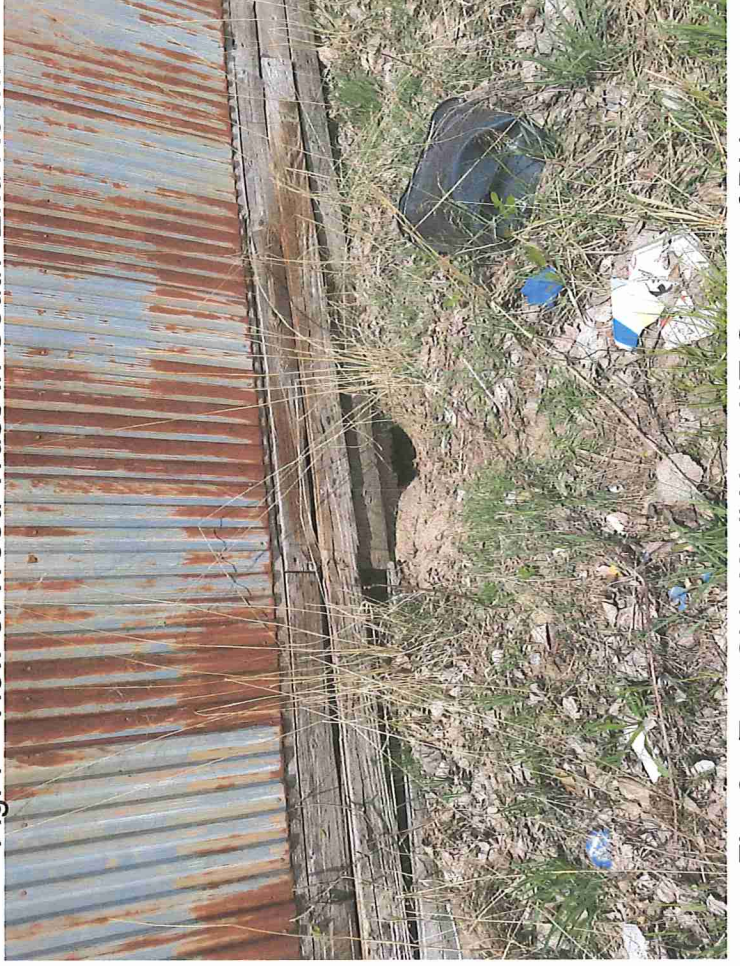
Fig. 8 - East Side Wall Near NE Corner of Bldg.

Figure 8 shows an animal burrow hole discovered along the east side of the building. This would only be a structural concern if these animal burrows resulted in large voids under the concrete slab floor.
